WATZEK HOUSE
BUILDING PRESERVATION PLAN
03.17.2019

Condition Assessment 11

PROJECT INFORMATION

PURPOSE

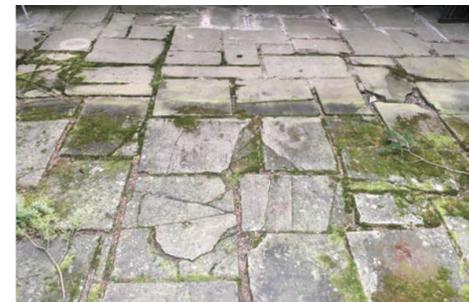
Image 3: Biogrowth and cracking of paving stone under the loggia, courtyard and portico.

Due to a lack of maintenance the stones have significant cracks, spalling, and severe biogrowth throughout. In some areas, the stones have depressed into the ground causing water to puddle and cause surfaces to deteriorate. The uniform appearance and high level of detail that existed when the stones were originally arranged, especially in the courtyard, is no longer existent. The mortar under the covered porch was previously patched with incompatible mortar. It is also sloping inward.

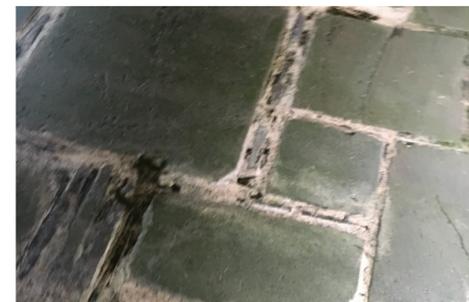
Image 4: Previous repair with incorrect ground match under passage from bedroom #2 to garage.

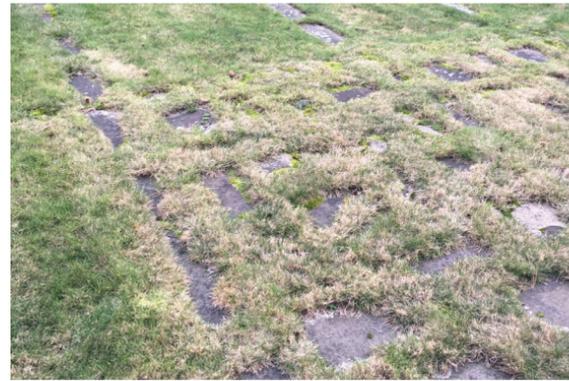
Image 5: Overgrown grass that has covered the pavers off the portico.

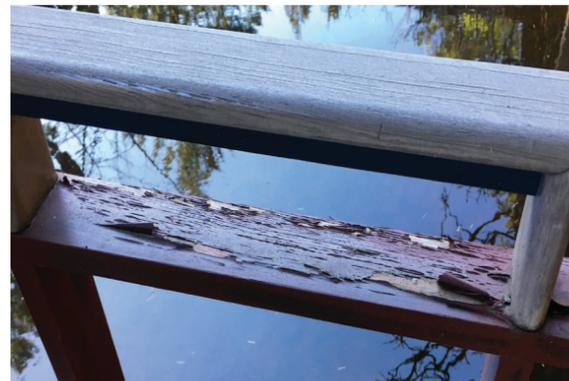
The wood is in good condition with moisture content ranging from 9%-13%, limiting the risk of rot. The paint is in poor condition, with a majority of the paint spalling off. The middle section of the railing is detached from the stone, allowing the frame to move out of alignment. Select areas of the railing have minimal biogrowth.

Image 6: Entrance railing with spalling paint and deterioration.

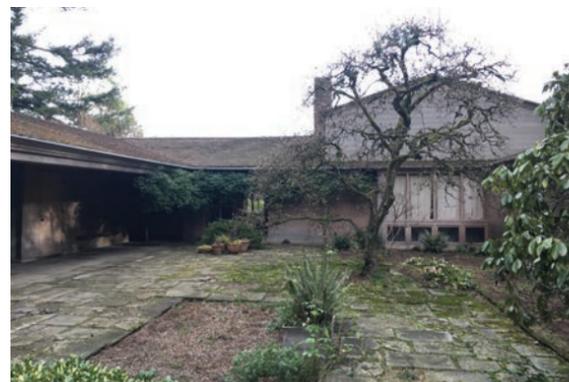
Image 7: Unpreserved courtyard landscaping with extensive moss growth.

Poor maintenance has diminished the design intention of the courtyard landscaping. While some of the concrete bricks are in place, others are missing or buried. A significant amount of pine needles and other debris covers the courtyard. Both wisteria plants are in contact with exterior siding. There is evidence of a small amount of biogrowth near the plants contact with the siding. The western wisteria is overgrown and in close proximity to the pond railing.

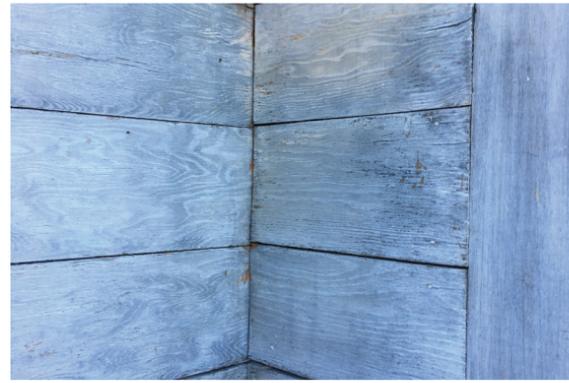
Image 9: Dirt buildup on siding.

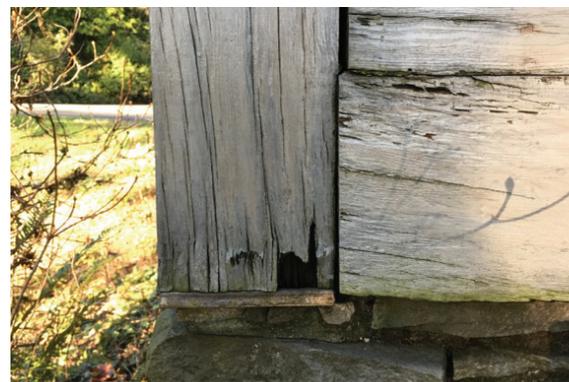
Some wood joints on the east, west, and south elevations have deteriorated and others are being expelled due to the contraction and expansion of the siding. There is biogrowth on the west and east elevation, especially on surfaces near the wisterias. This accumulation of moisture has begun to move the panels away from each other. The 6"x6" corner post on the southwest corner of the garage has significant moisture deterioration approximately 2' from the base. The corner post on the southeast corner was replaced with a Dutchman repair.

Image 11: Southeast corner post on garage that is decaying.

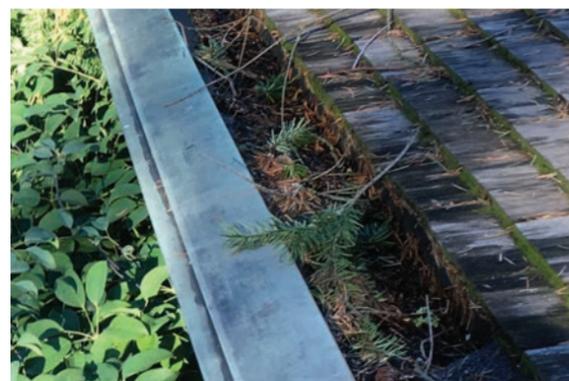
Image 12: Vegetation and duff build up in gutters and roof.

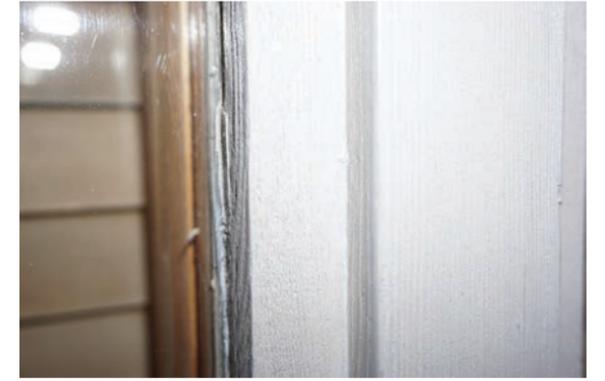
Image 13: Failing window glazing.

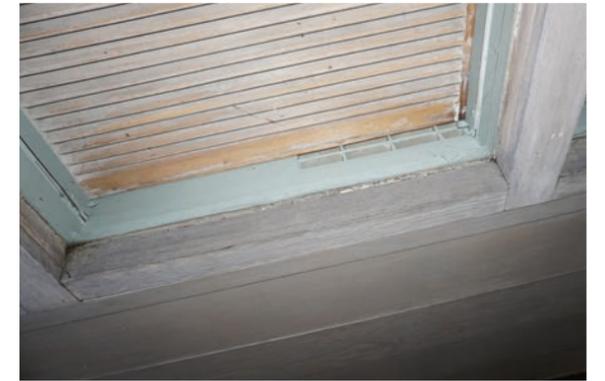
Image 14: Failing window glazing.

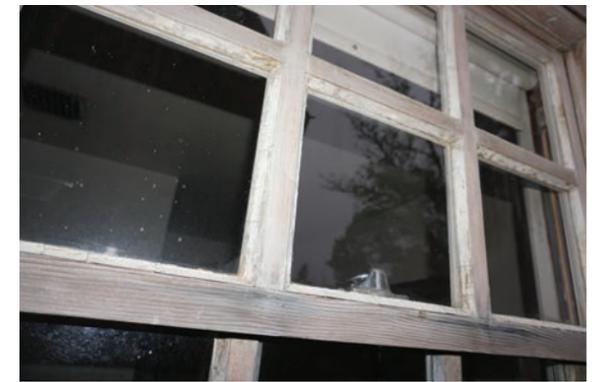
Image 15: Failing window glazing.

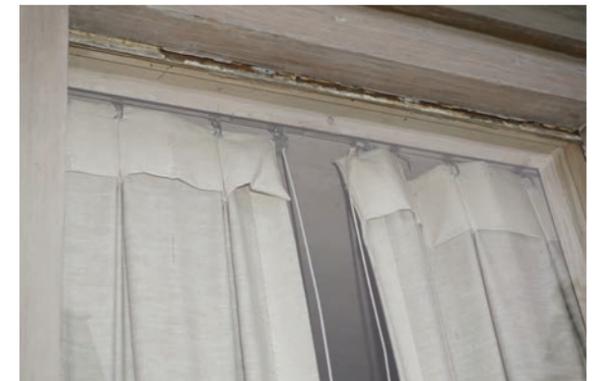
Image 16: Failed window glazing at library window.

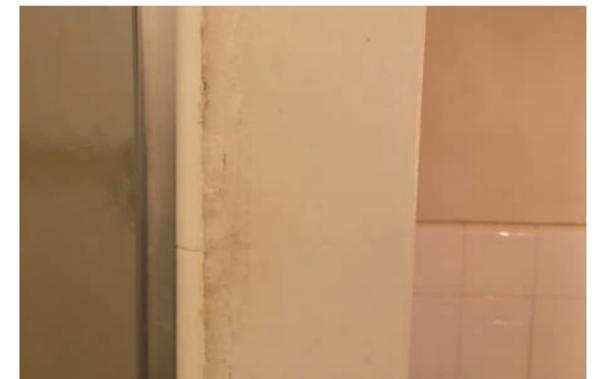
Image 24: Water stained plaster in bathroom #2.

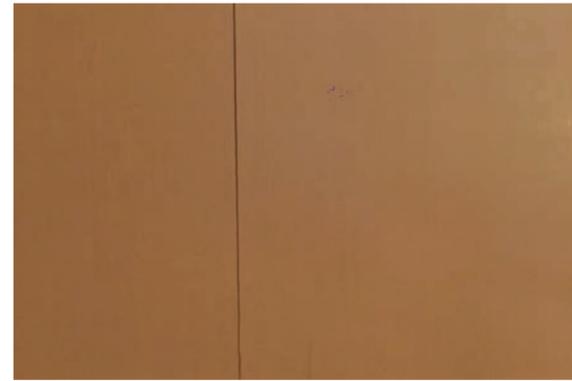
Plaster cracking slightly in locations on the north wall. Previous plaster repairs visible as raised dileniations on wall.

Image 25: Cracking in the plaster along the dining room walls.

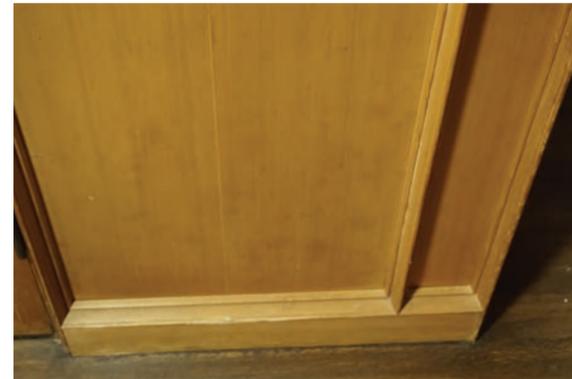
Image 26: Chipping on entrance hall trim and baseboard.

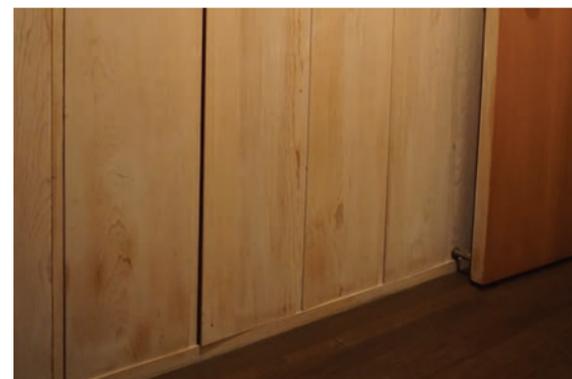
Image 28: Loose board in hallway #2.

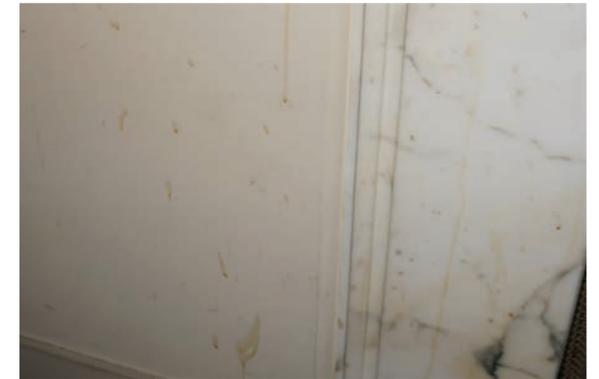
Image 30: Yellow staining to the left of fireplace in library.

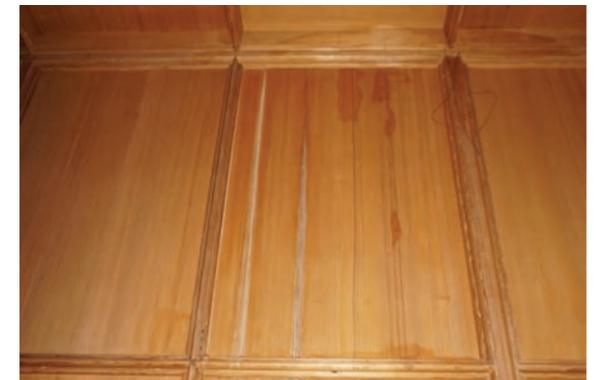
Image 31: Water stain from previous roof leak in living room above fireplace.

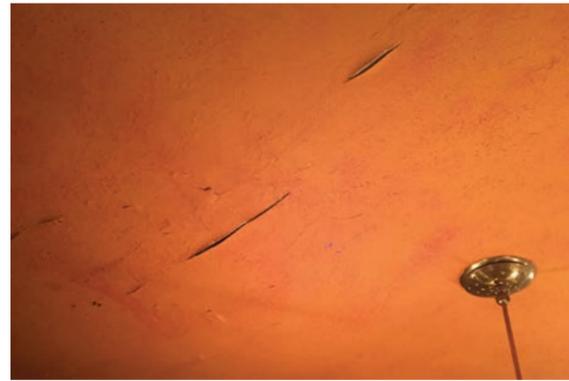
Image 33: Crack in plaster above dining room light fixture.

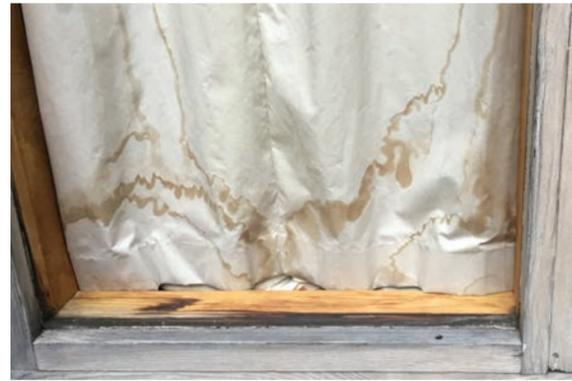
Image 53: Water damage on curtains from high moisture levels in library.

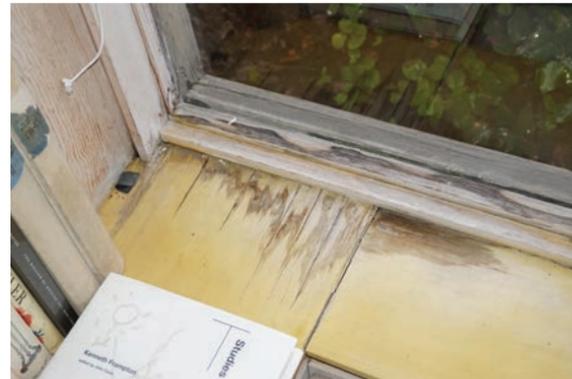
Image 54: Water damage on windows sill in library.

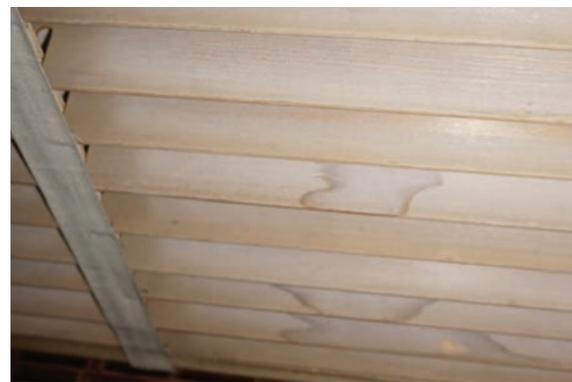
Image 55: Water stains on wood blinds in living room.

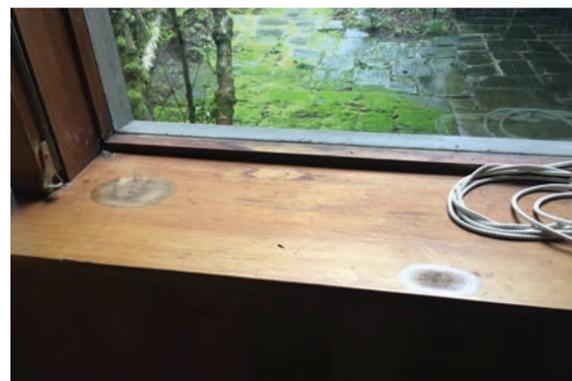
Image 56: Water stains on window sill in sleeping porch.
