WATZEK HOUSE
BUILDING PRESERVATION PLAN
03.17.2019

Condition Assessment 11

PROJECT INFORMATION

PURPOSE

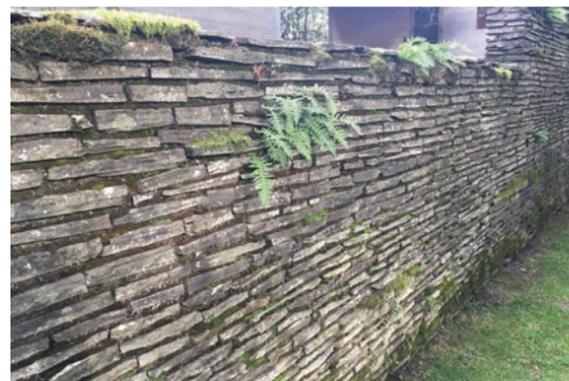
Image 8: Stacked stone wall on south side with vegetation and biogrowth.

Condition

There is mild spalling on approximately 25% of the surfaces. Mortar joints are failing in many locations, allowing for excess moisture to penetrate deeper in the stones. The top layer of stones has lost the majority of its mortar and is loose, and even the wood box installed

at the west end as a preventative measure has decayed. A significant amount of biogrowth has formed along the wall, including moss in mortar joints and lichen along the surface.

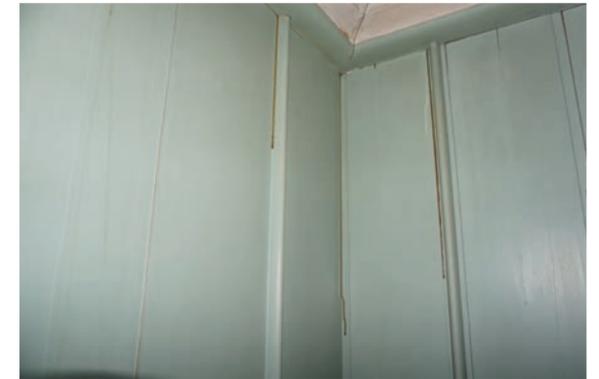
Image 22: Brown substance on pine paneling in bedroom #3.

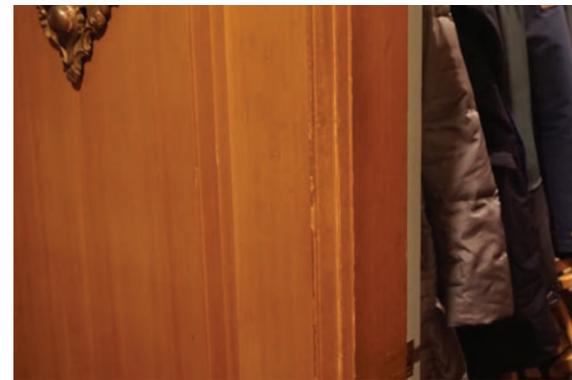
Image 27: Chipping on door frame trim in entrance hall.

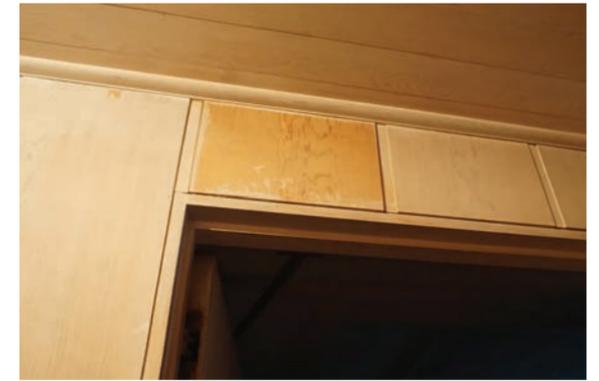
Image 29: Non matching panel in hallway #2 above bedroom #3 door.

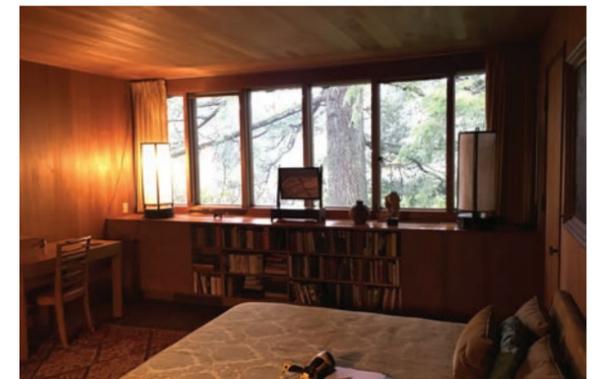
All casement windows are either difficult to open or

Image 44: Windows in bedroom #2.

inoperable. The blinds function properly with some maintenance.

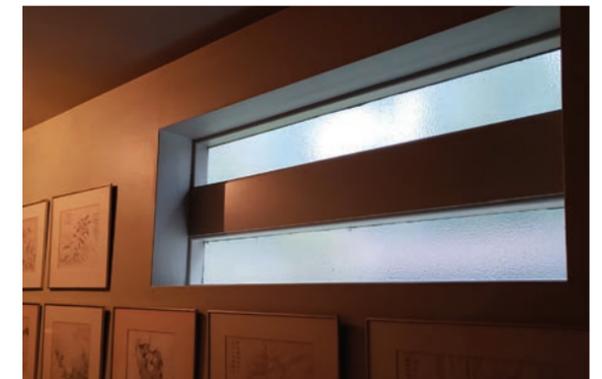
Image 52: Pebble texture glazing on hallway #1 windows.
